USGS EAA  
Nomination & Project Information Form

**Title of Nomination: Storm Water Management National Center**

**STORMWATER MANAGEMENT PLAN  
 STA. 0+00 TO STA. 5+50**

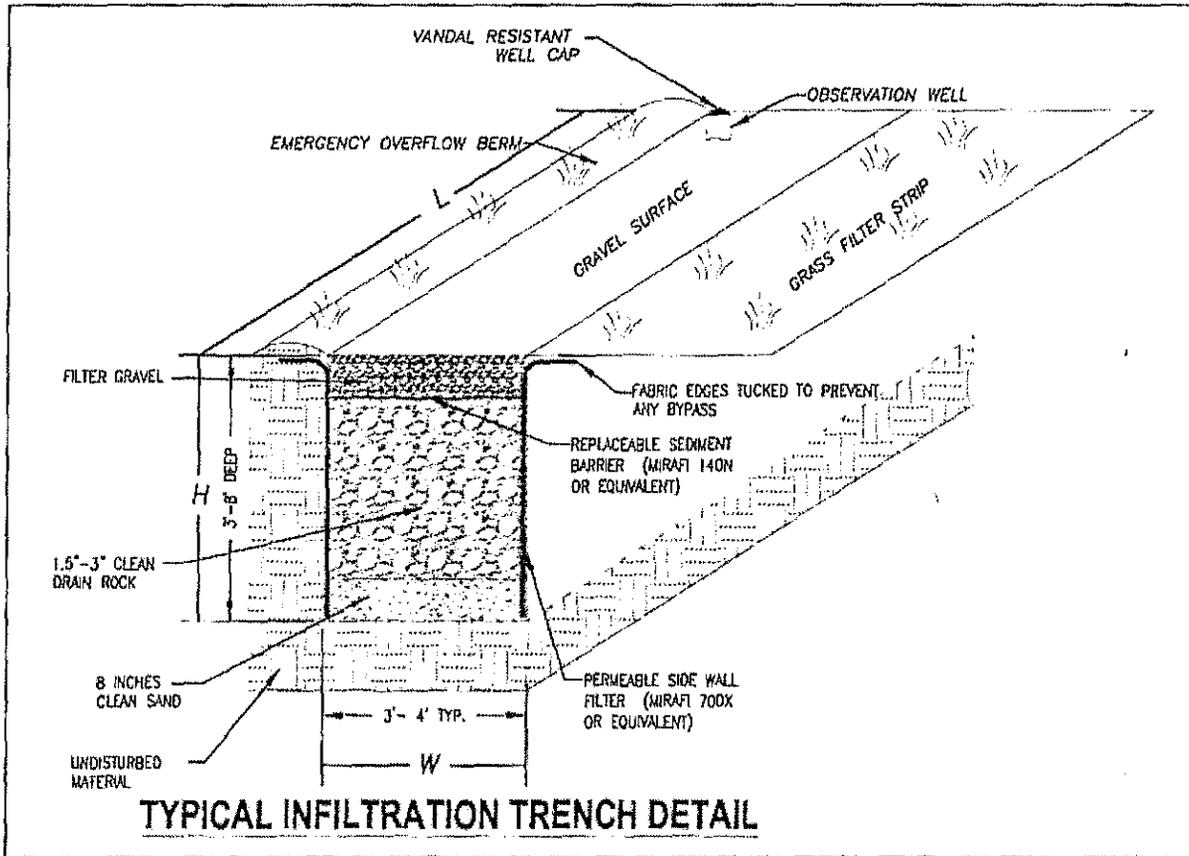
Working together with engineers a new design was approved by USGS and GSA that through infiltration trenches and piping would retain over 95% of storm water runoff back into the ground area. Attached are detail drawings showing typical views of the infiltration trench design that was utilized and installed. The typical trench is about 4 foot deep and wide with a layer of sand, a layer of clean rock, fabric material, and filter gravel.

Also, installed where three areas each 16 foot wide by 26 foot long of 5 foot perforated pipe to allow heavy rains to fill as a holding area to allow the water to migrate back into the ground. If the storm was too heavy the system is connected to the retention pond to run off excess water should the system fill up. The pipe was laid in the ground in rows to create a holding tank area that would allow the water to migrate through the perforation back into the ground slowly.
